Marine Safety Investigation Report

VERY SERIOUS MARINE CASUALTY | May 2025

Sophia Z

Electrocution on 30 August 2024

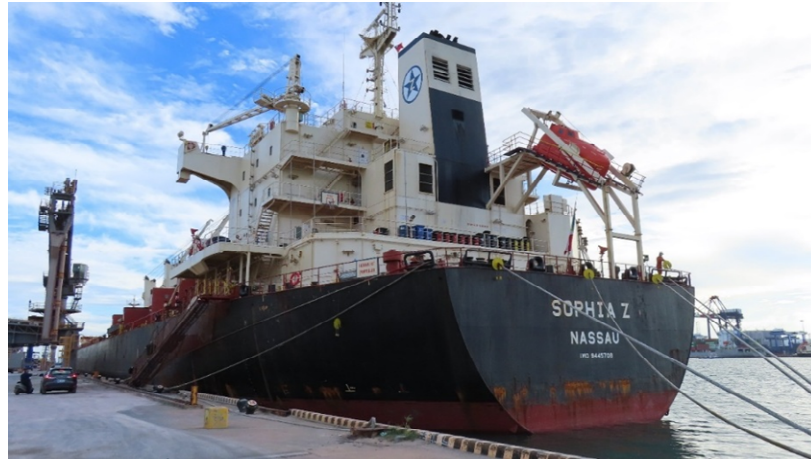
Sophia Z was a five hold, geared bulk carrier with a deadweight of 57,700 tonnes. The bosun's store was under the forecastle deck, accessed from main deck level. The vessel was last subject to a port state control inspection on 01 June 2024 and a flag state annual inspection on 12 August 2023. Neither identified any deficiencies.
