# Marine Safety Investigation Report

VERY SERIOUS MARINE CASUALTY | June 2025

**Margaritaville at Sea Islander**

Fall from height on 10 October 2024

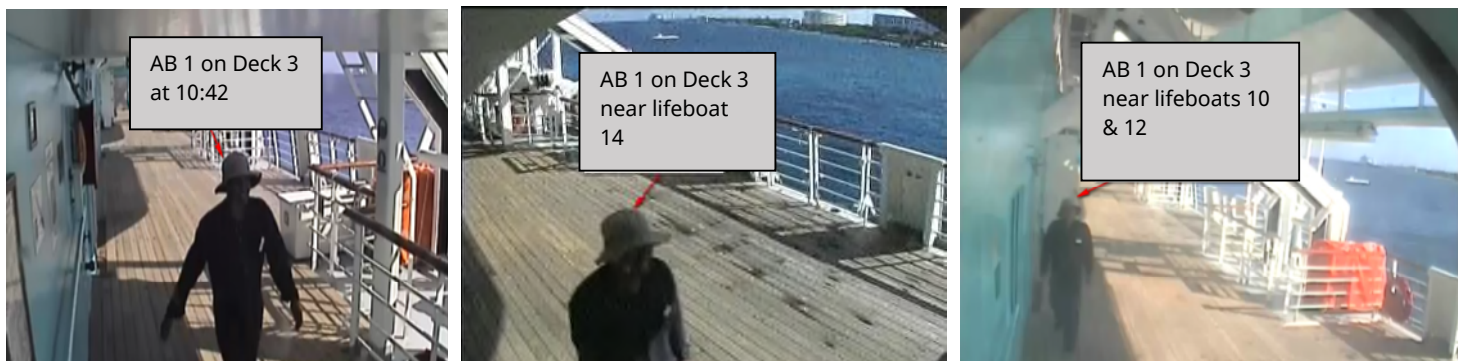
### AB1 on Deck 3 port side passing lifeboats 16, 14, 12 and 10 – proceeding forward

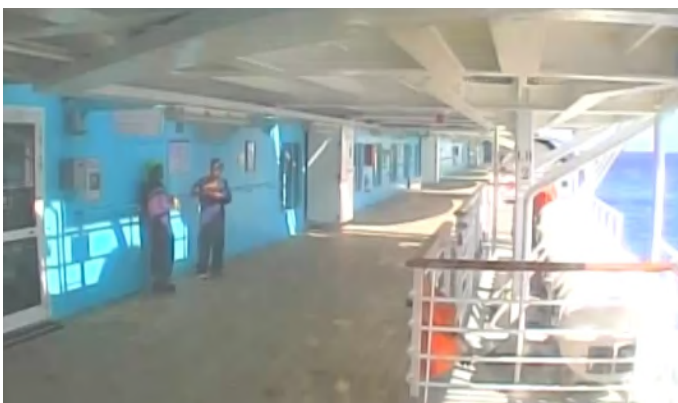
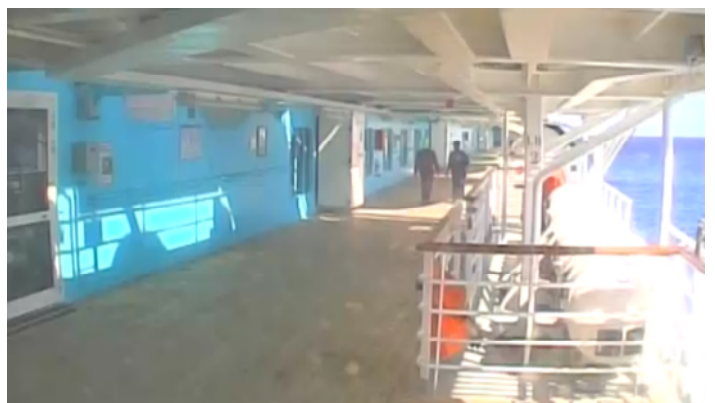
**Two assistant bosuns conversing (left) and walking aft at 11:01 (right)**

At 11:03 the assistant bosuns were walking pass lifeboat 6 when they heard someone exclaim “ADUH<sup>1</sup>” –, followed by what they believed was a landing onto a platform behind them.
