Marine Safety Investigation Report

VERY SERIOUS MARINE CASUALTY | June 2025

Master Ru

Capsize of vessel on 11 July 2024

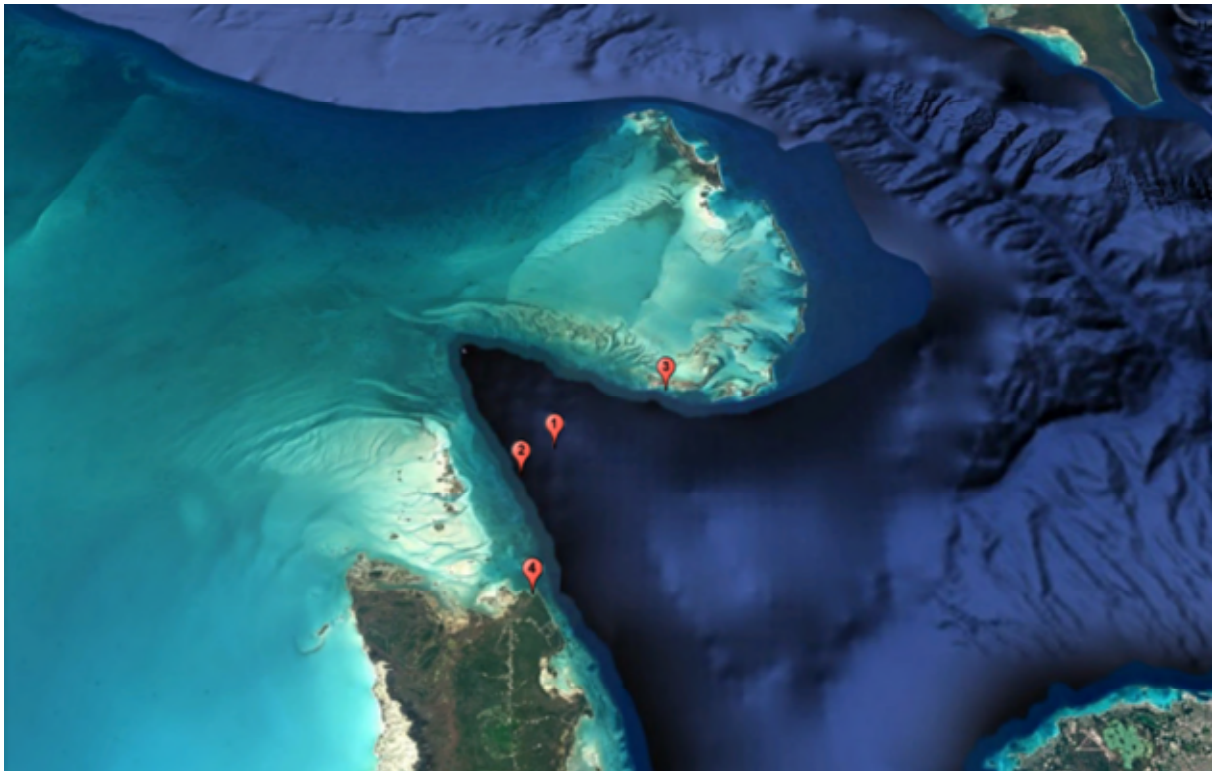
Approximate locations during SAR operations (Google Earth)

- 1** The EPIRB From the Master RU activated at 25° 19.2'N 78° 00.1' W prompting SAR Responders towards the scene.
- 2** The USCG reported spotting the second life raft at position 25° 18' N 78° 03' W.
