# Marine Safety Investigation Report

into a fatality on **Grandeur of the Seas** on  
**21 January 2025**

Date of Issue: 23 January 2026  
Bahamas Maritime Authority  
120 Old Broad Street  
LONDON  
EC2N 1AR  
United Kingdom

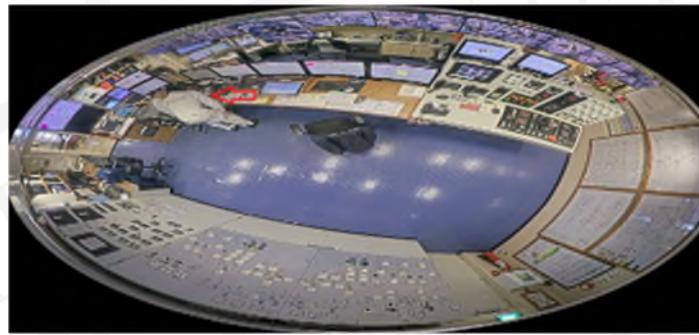
The electrical cadet entered the ECR at 15:44 and discussed the sensor issue with the 2/E. He also observed the trend analysis for both tanks involved in the transfer (M6P and M4) on the VMS.

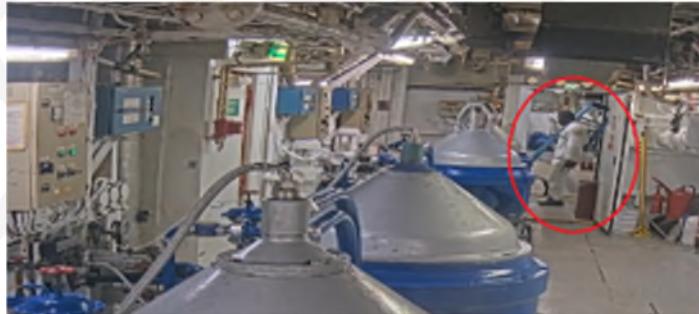
He departed the ECR, and at 15:54 he is seen carrying a ladder in the direction of tank M4, which was subsequently rigged for entry into the access space above tank M4, which contained the sensor.

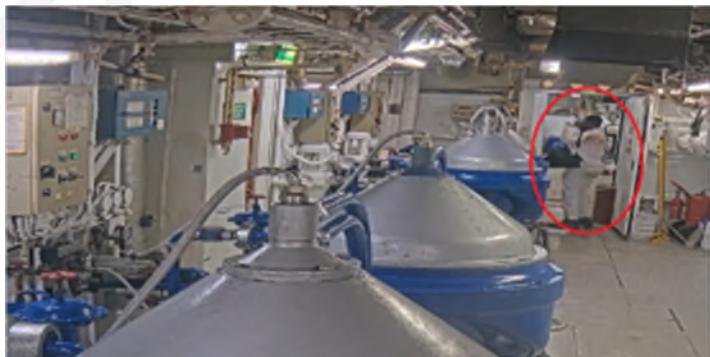
After rigging the ladder, the electrical cadet returned to the separator room to collect his tool bag. He then proceeded in the direction of tank M4.
