# Marine Safety Investigation Report

## Algoma Victory

Fall from height on 01 April 2026

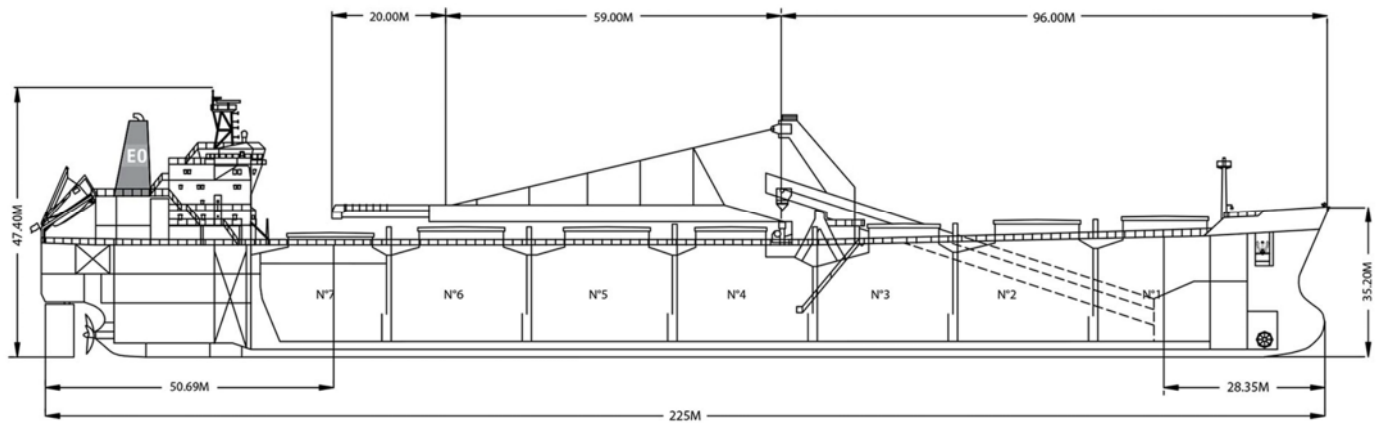
General arrangement of Algoma Victory

At the time of the casualty, the boom was in a spillage position. The boom fitted conveyor belt was retracted and the boom was at an angle allowing it to be completely clear of cargo holds 6 and 7, mostly clear of cargo hold 5, and partially clear of cargo hold 4 while hold washing was ongoing.
