**“M.V. Atlantic Hero”**

**Report of the investigation into the collision between the  
*Atlantic Hero* and *Oriental Pioneer* in the approaches to the  
Singapore Pilot Station on 2<sup>nd</sup> July 2013**

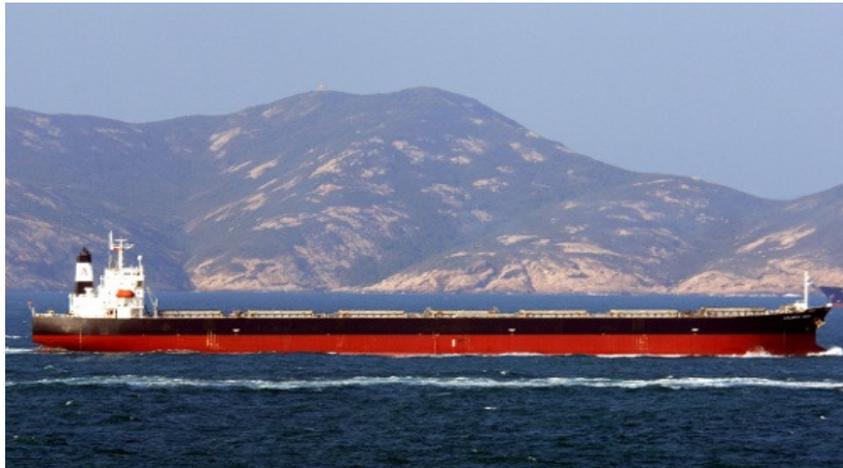
**Atlantic Hero**

- 2.1 The *Atlantic Hero* is a 7 hold, gearless Bulk Carrier of all steel construction registered in the port of Nassau, Bahamas
- 2.2 The vessel was constructed in 2005 in Okayama, Japan and at the time of the incident, was under classification with Nippon Kaiji Kyokai (Class NK). The vessel was owned by the Overseas Marine Company and was managed and operated by Sun Enterprises Ltd. The following principal particulars were noted:

• Official Number	-	8001515
• IMO Number	-	9291119
• Length overall	-	225.0 metres
• Breadth	-	32.27 metres
• Depth	-	19.30 metres
• Gross Tonnage	-	38871 tons
• Net Tonnage	-	25194 tons
• Deadweight	-	75804 tonnes
• Call Sign	-	C6XD5

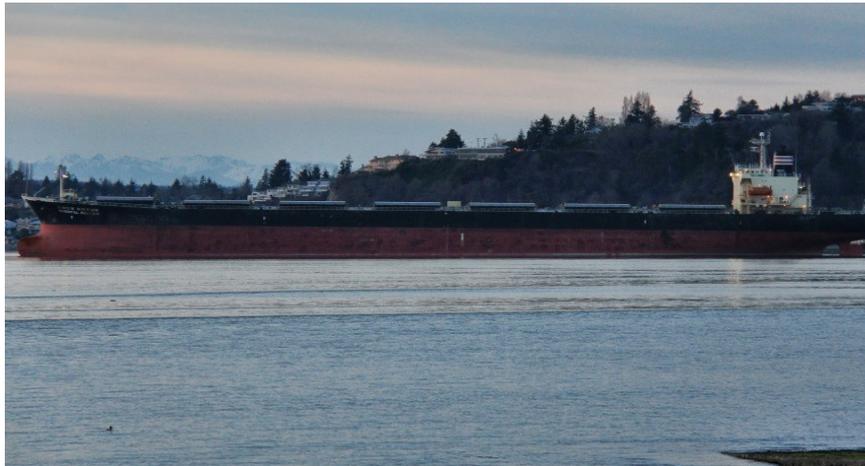
## Oriental Pioneer

- 2.3 The Oriental Pioneer is a 7 hold, gearless Bulk Carrier of all steel construction registered in the port of Jeju, South Korea.
- 2.4 The vessel was constructed in 1996 and at the time of the incident, was under classification with the Korean Register of Shipping. The vessel was owned by the NYK Bulk ship Korea Company Ltd and was managed and operated by STX Marine Services Ltd. The following principal particulars were noted:

•	IMO Number	-	9139983
•	Length overall	-	225.0 metres
•	Breadth	-	32.00 metres
•	Gross Tonnage	-	36604 tons
•	Net Tonnage	-	25194 tons
•	Deadweight	-	69606 tonnes
•	Call Sign	-	DSPN6
