“VOS SAILOR”

**Report of the investigation into
STORM DAMAGE**

**whilst on dodging manoeuvres near the Balmoral
Platform in the North Sea**

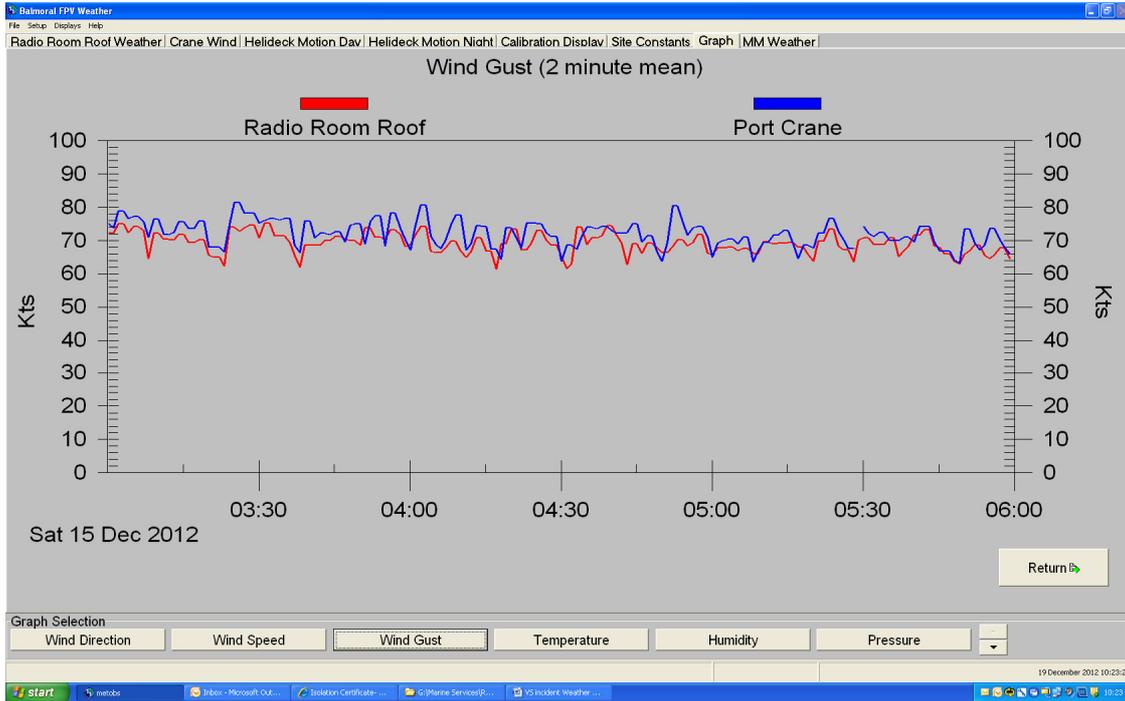
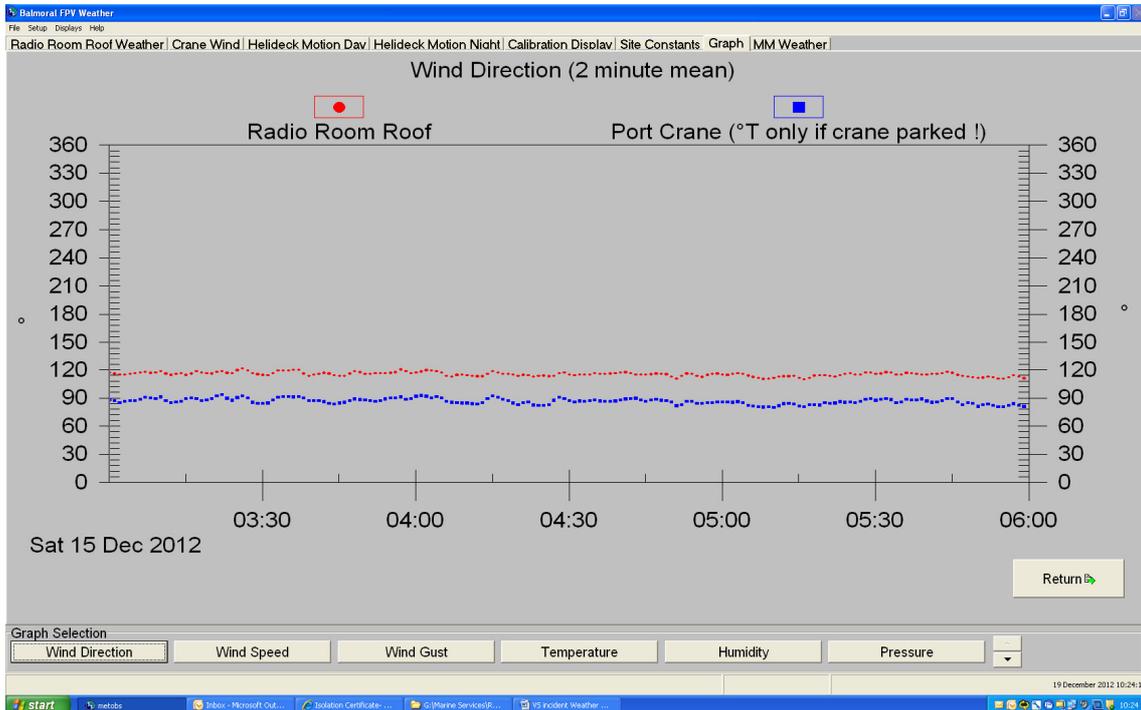
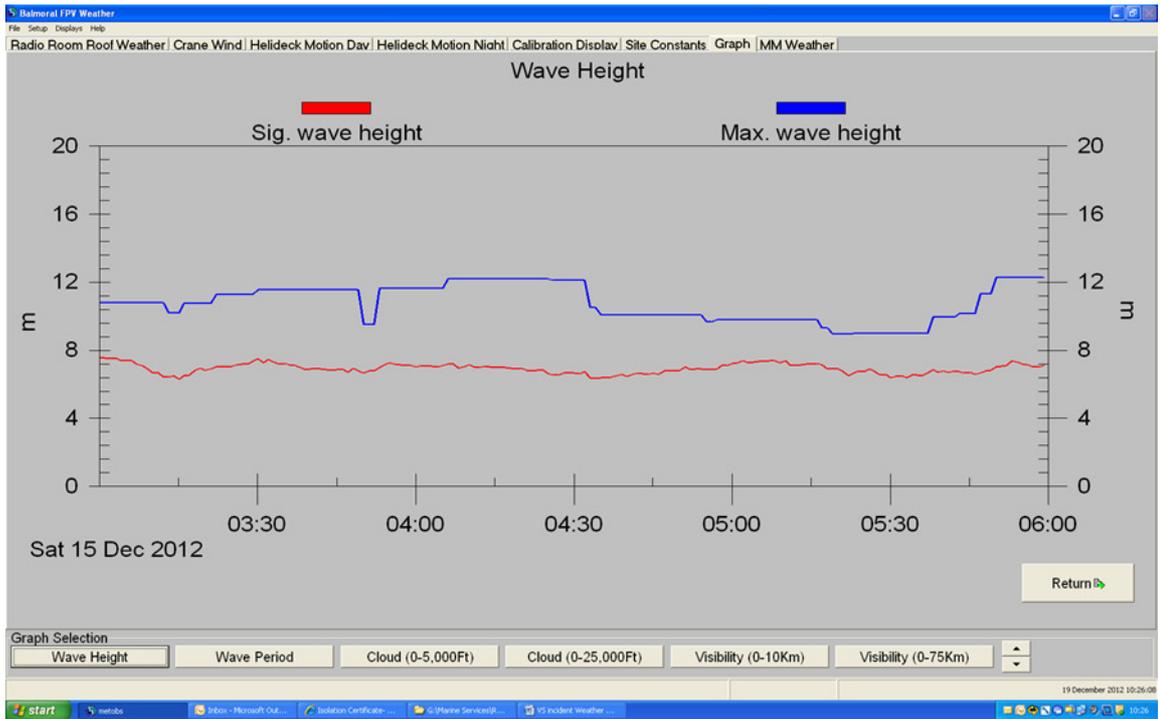
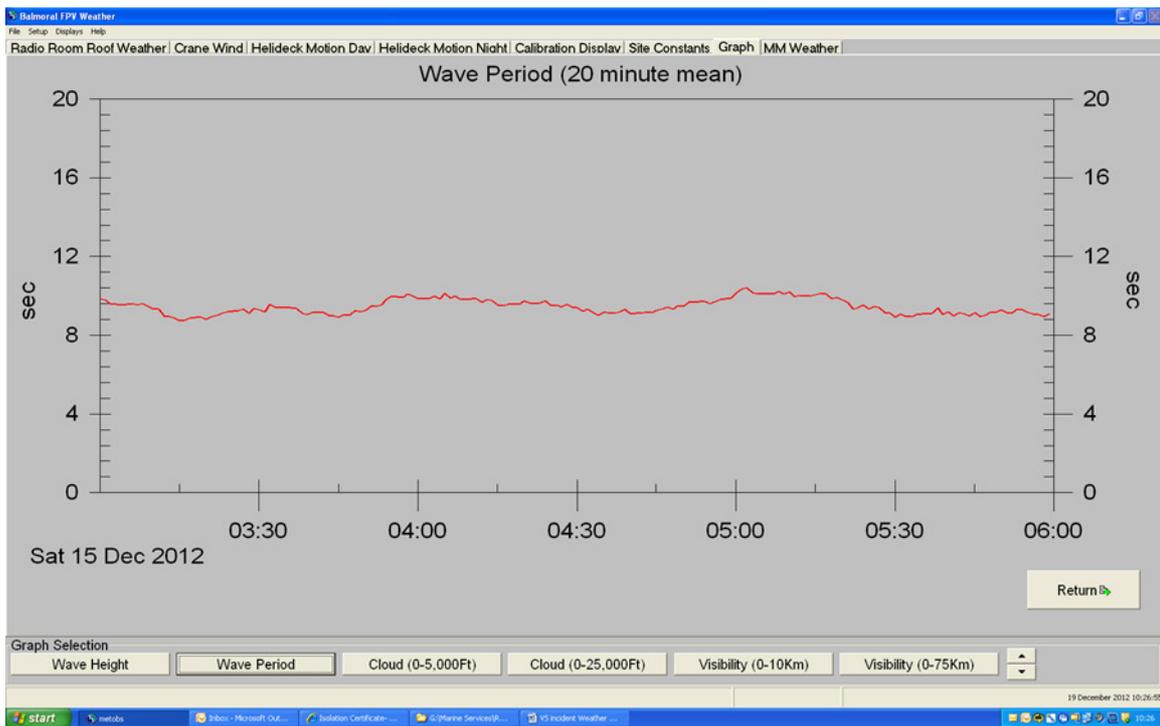
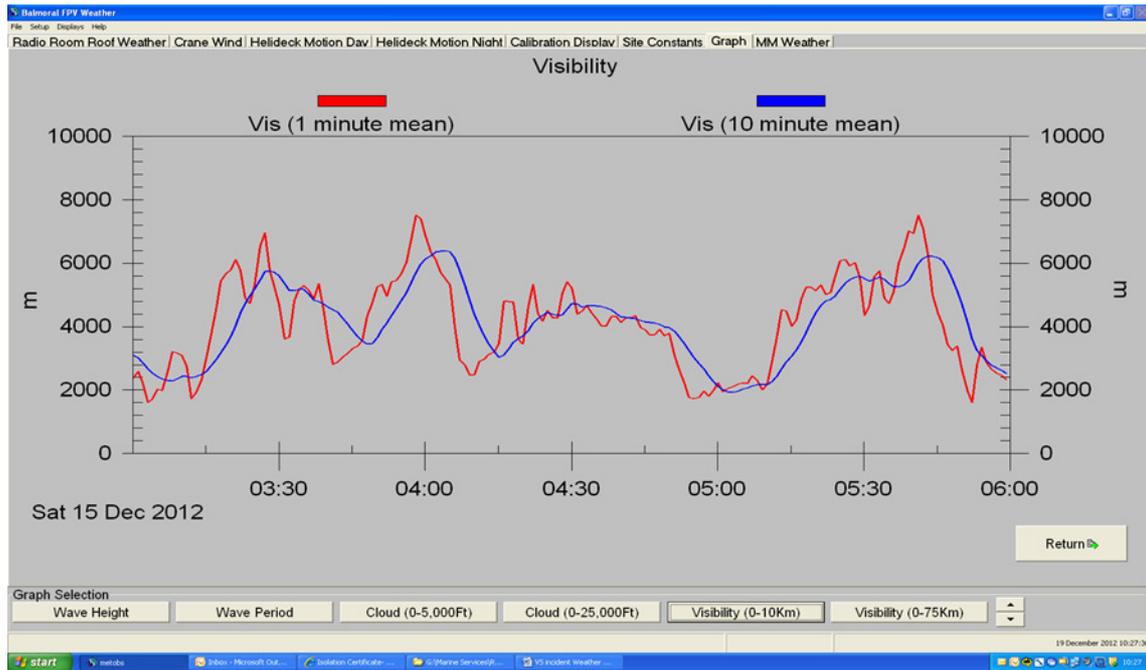
APPENDIX IV: Balmoral Platform Weather Observations

- 3.2 The incident occurred shortly after 0400 hours on the 15th December 2012.
- 3.3 The reported weather conditions at the time of the incident, as received from the weather observation station on board the platform, were as follows: WIND Dir-090 Spd-50 Kts (Gusting 70Kts). SEA Dir-120 with a Wave Height ranging between 10 and 12 metres
